09-01-09-02

High Mounted Stop Lamp (HMSL) – Service replacement procedure

Bentley Continental GT and GT derivatives upto and including 2011 Model Year

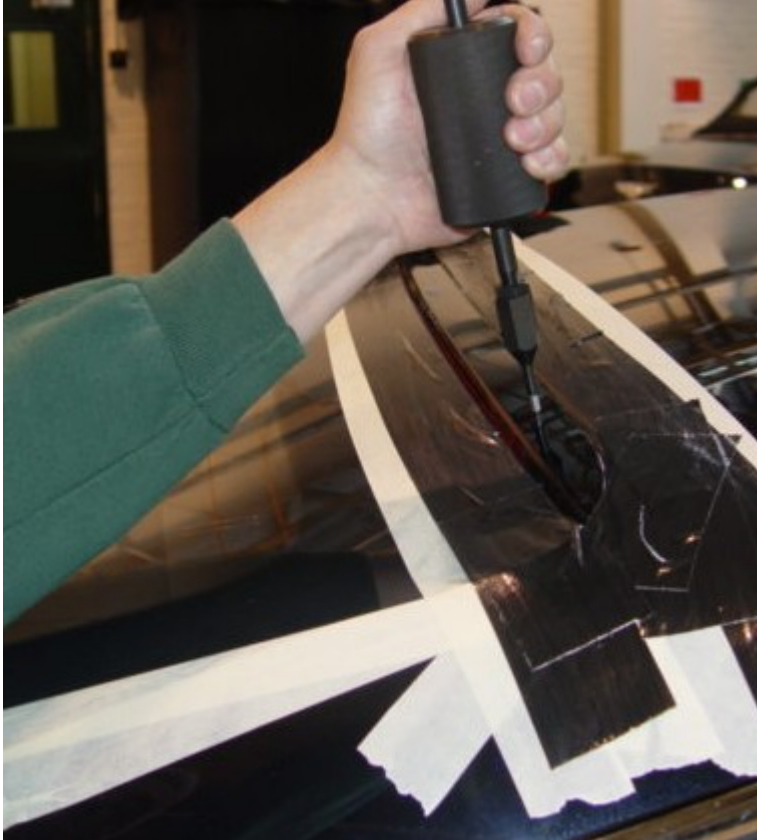
Figure 3

- Screw slider hammer RH 13237 into each 3mm hole in turn and gently pull the stop lamp from its securing clips (see Figure 3)
 - It is understood that the original ribbon cable electrical connection will break as a result of this removal process

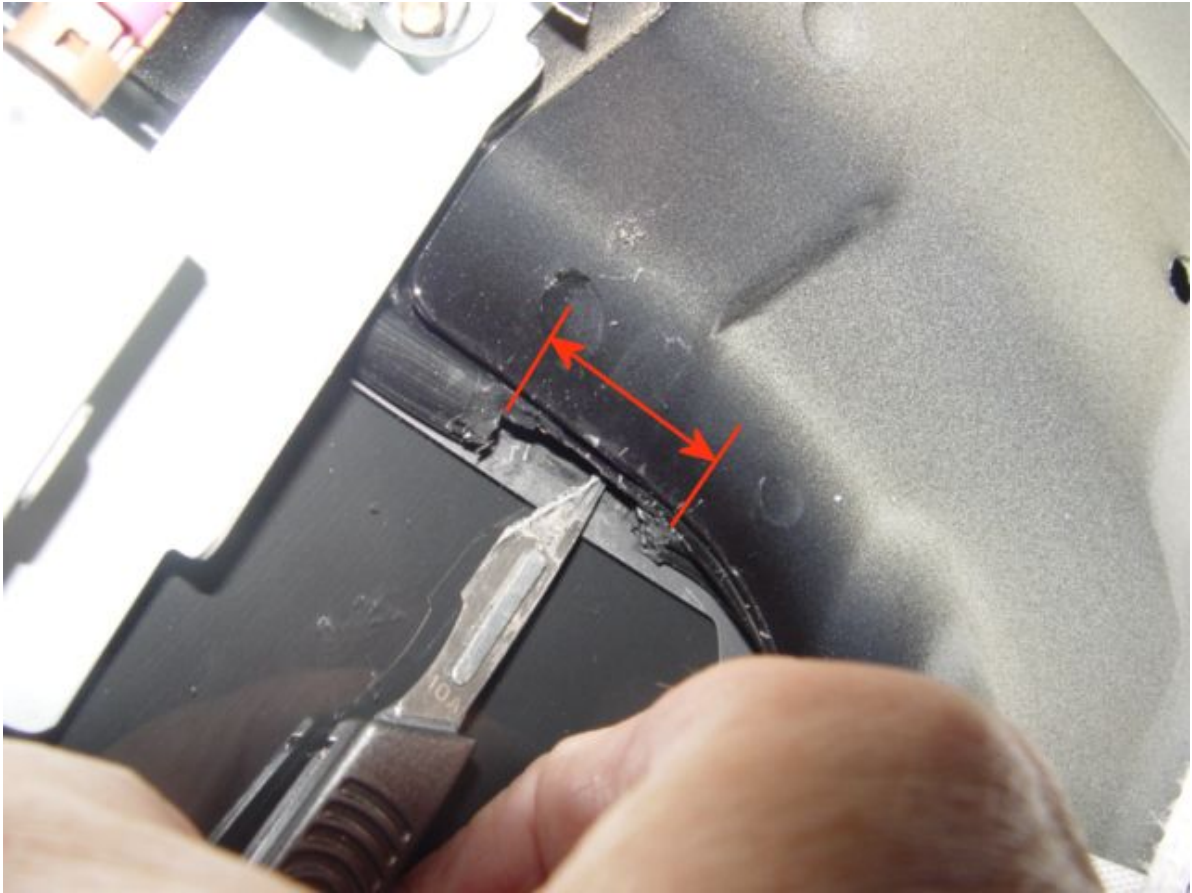
Figure 6

8. Referencing Figure 6, produce a slot in the screen adhesive to allow the passage of the de-pined cable that is attached to the new HMSL. The slot should be produced at the original cable entry point

- Using a surgical scalpel, remove approximately 25mm of old adhesive
 - The majority of the cutting should be done from inside the vehicle as access is more direct and less likely to damage the glass

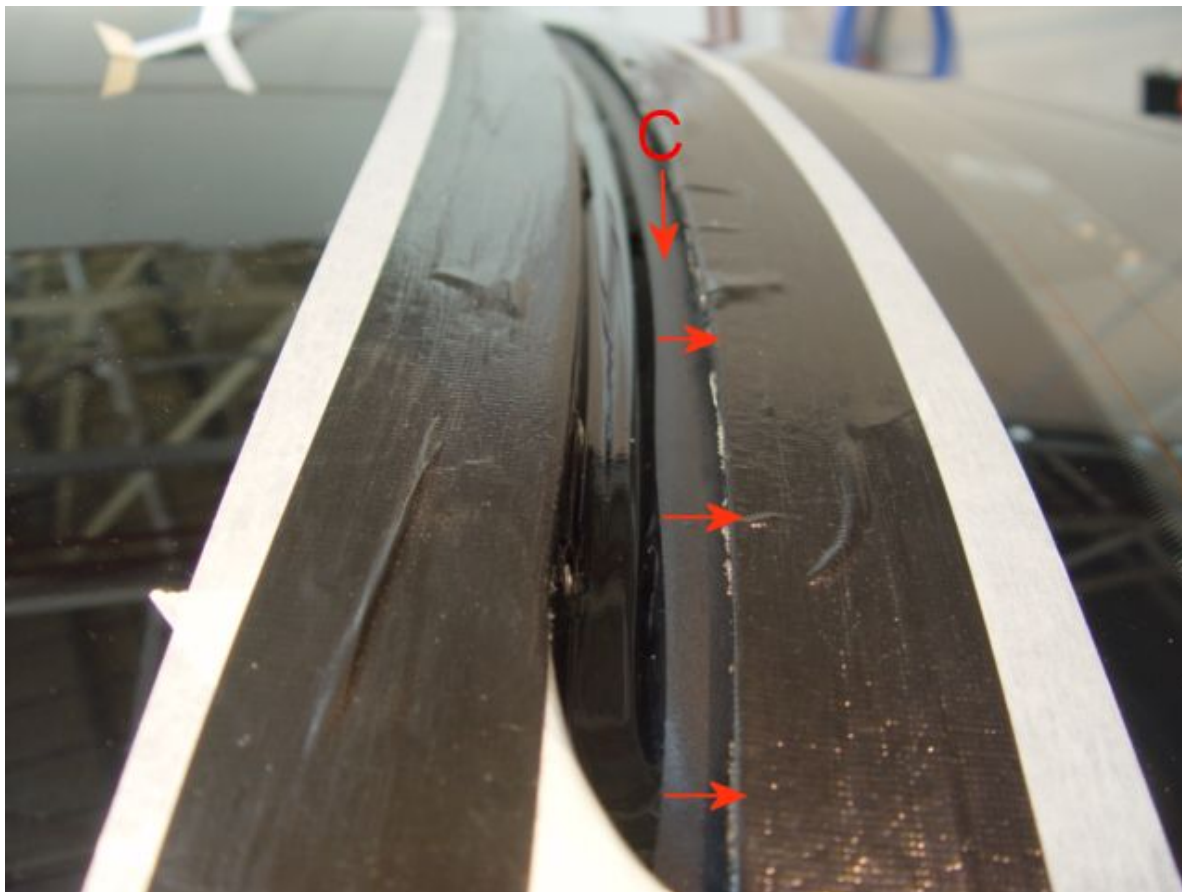
11. Apply the obscuration strip (part number 3W8853995) to the prepared body flange (see Figure 9 and 10)
 - The obscuration strip (C) should be applied so it fits under the overhang of the glass. Its function is to cover the body flange that would otherwise be visible when the new stop lamp is fitted

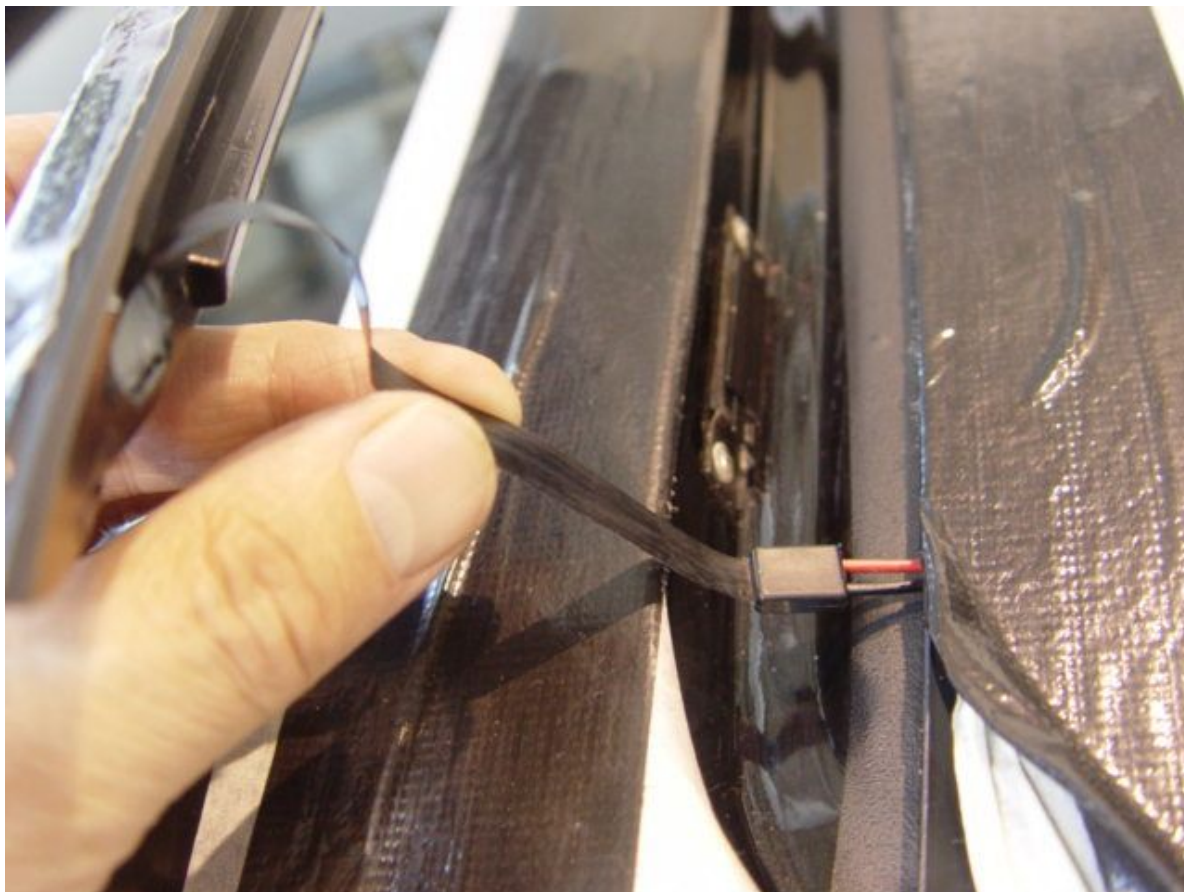
Figure 12

- Feed the de-pined terminals and cable through the slot whilst positioning the HMSL (see Figure 12)
 - In the case of the ribbon cable ensure the cable lies flat, takes on its natural route and is not creased

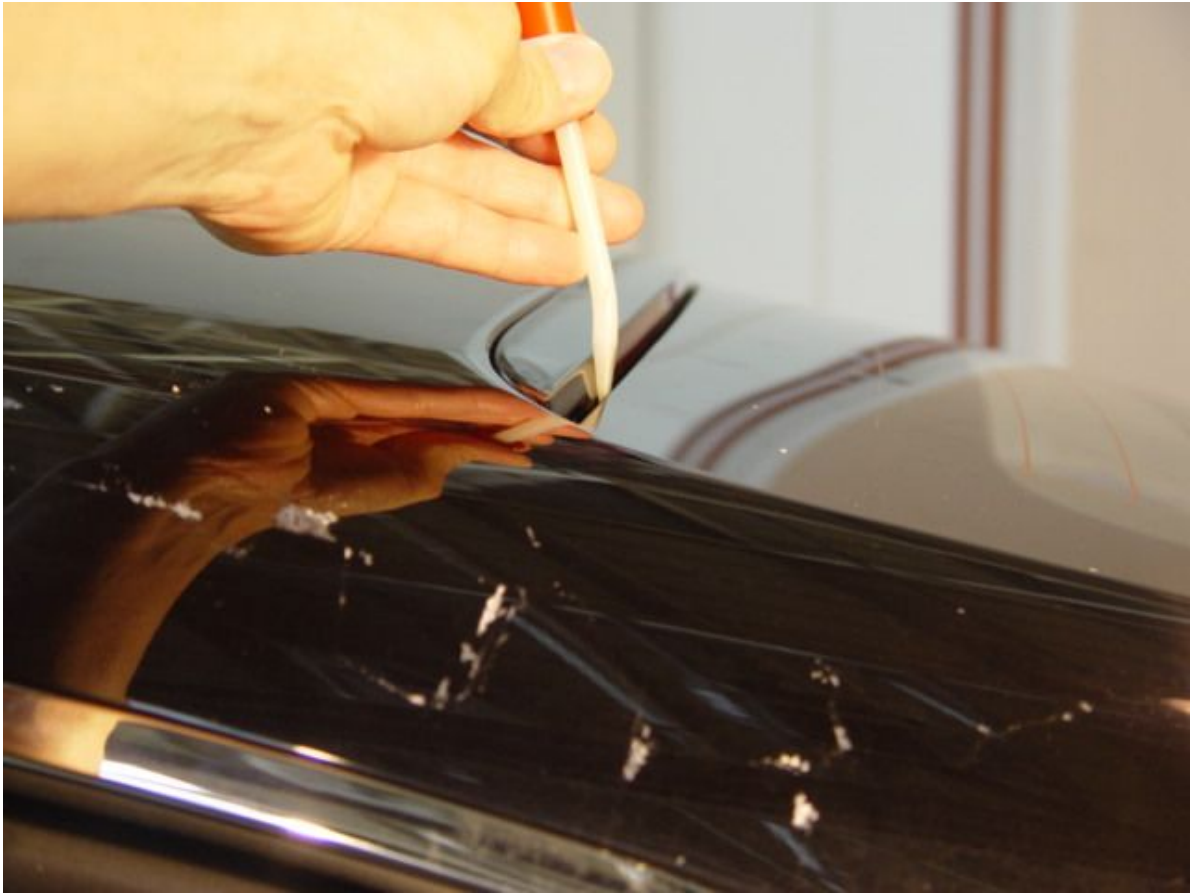
Figure 13

14. Remove all the protective tape from the vehicle body and the lamp
15. Use a soft blade, such as PM27707PA, to gently push the ribbon cable on to the flange to promote adhesion (see Figure 13)

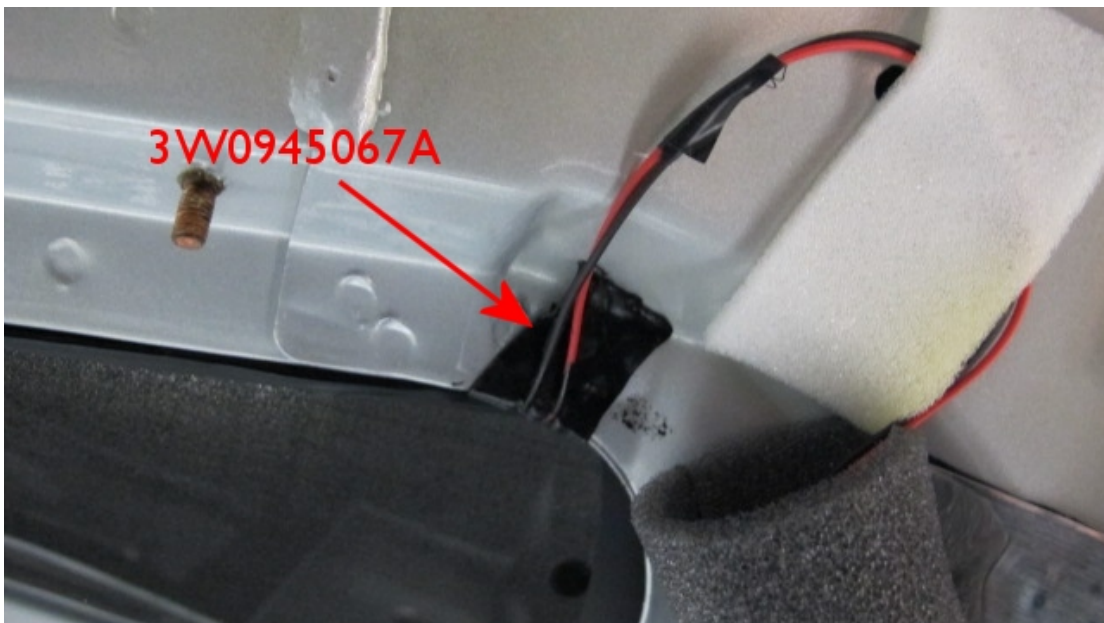
17. Inside the vehicle remove the final length of adhesive backing from the ribbon cable and affix the cable to the vehicle body. In the case of the round section cable fit the adhesive pad (part number 3W0945067) to the edge of the inner screen aperture flange. This serves to secure and protect the cable. When fixing either cable type allow sufficient radius at position 'D' to avoid a hard foul with the edge of the body flange(see Figure 14 or 14a)

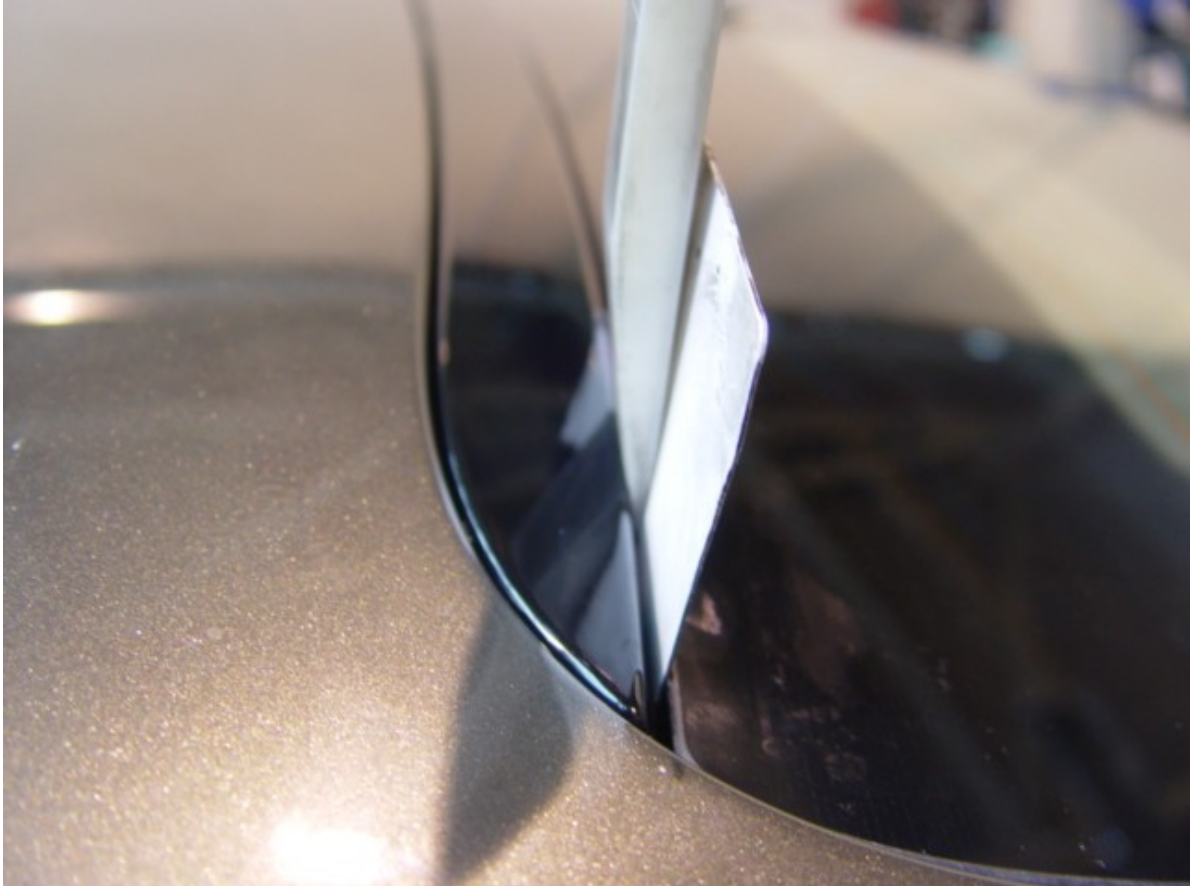
Figure 15

18. Use Betafill seam sealer to re-fill the slot carrying the cable
 - Blank off the exterior exit point of the cable to enable the Betafill to be compacted up to outside exit point (see Figure 15)

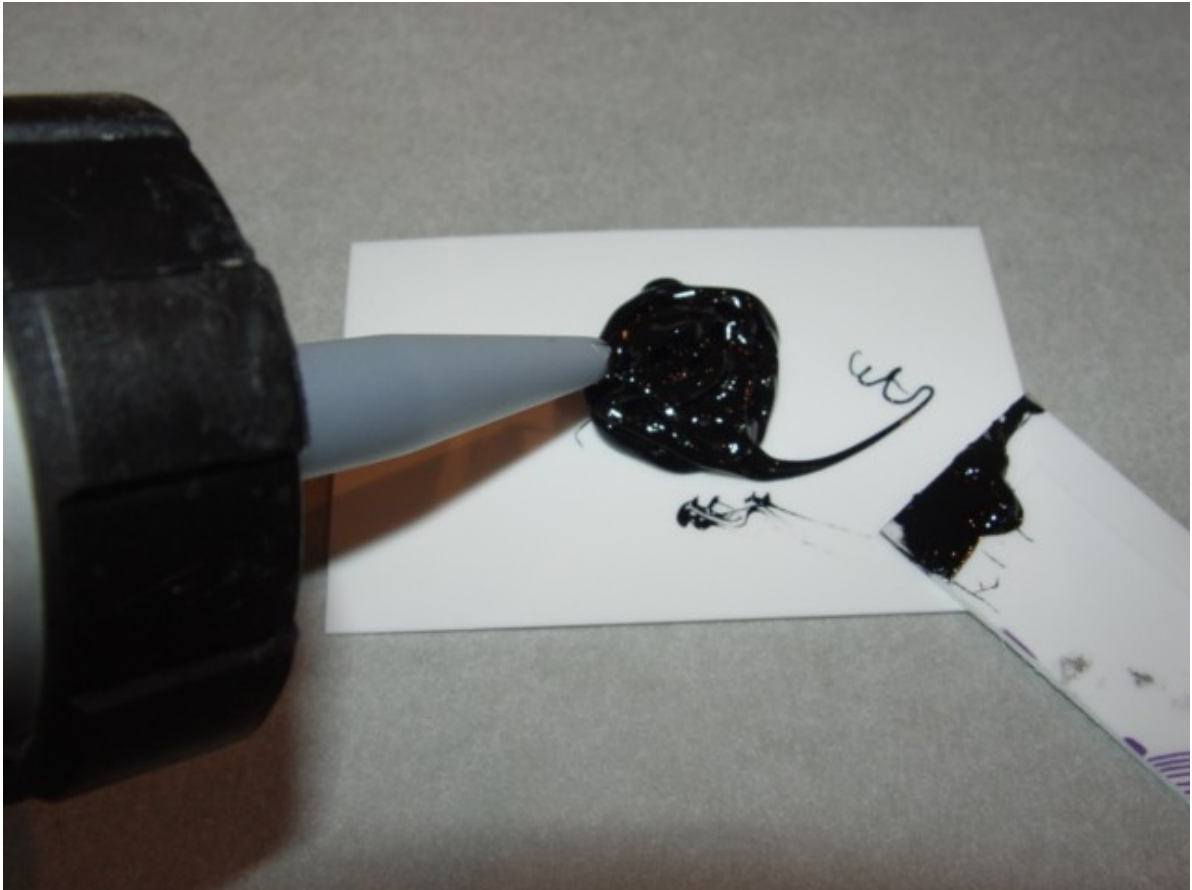
Figure 16

- Apply sufficient Betafill onto a plastic trowel (see Figure 16)
 - Use a narrow spatula to fill and compact the Betafill into the cavity from inside the vehicle specifically with a round section cable ensure that Betafill completely encapsulates the two cables to avoid water ingress (see Figure 17)
